SUBSURFACE IMAGING

Bridge Deck Rebar Location -Atlantic Testing Laboratories

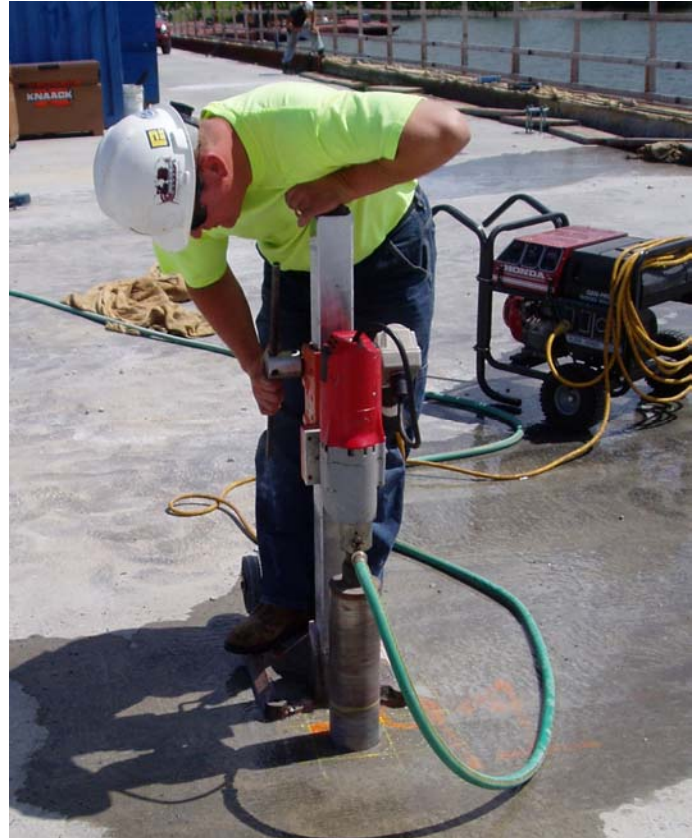
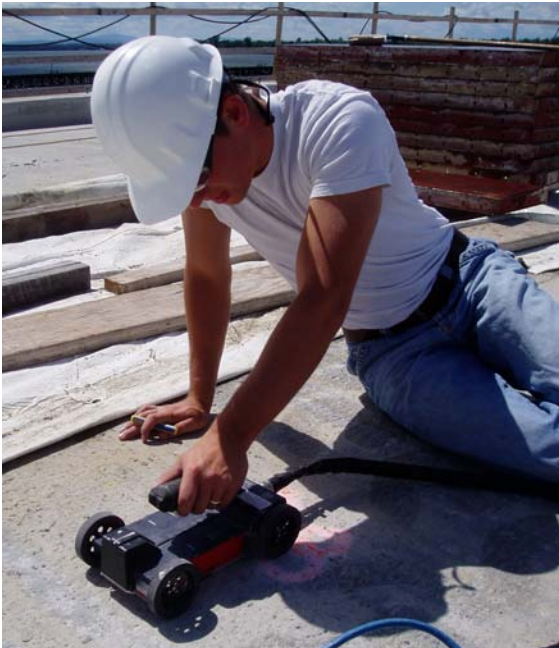
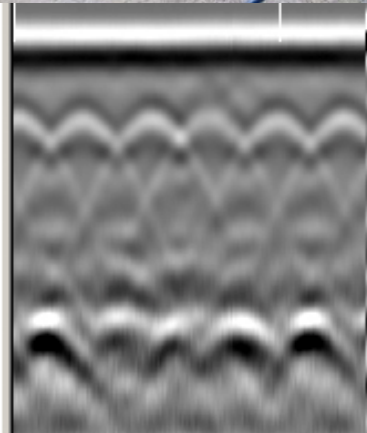
A materials testing company was continually hitting rebar during coring for concrete integrity tests on a new bridge deck in northern Vermont. Using a 1.5 GHz antenna with a hand cart, SPECTRA provided real time field-markout of rebar positions on the bridge deck in advance of the coring crew. This allowed the testing company to safely obtain cores without compromising the integrity of any reinforcement.
